Dacia Duster
Standard Safety Equipment

2017 ★★☆☆☆

Tested Model	Dacia Duster 1.5 diesel, LHD
Body Type	- 5 door SUV
Year Of Publication	2017
Kerb Weight	1303kg
VIN From Which Rating Applies	- all Dusters
Class	Small Off-Road

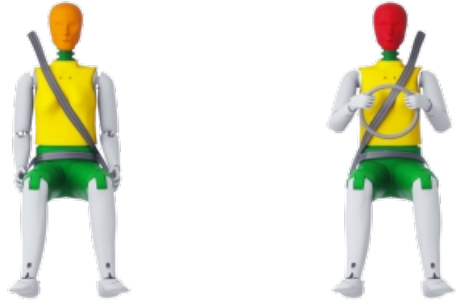
Frontal Full Width 3.4 Pts

The passenger compartment of the Duster remained stable in the frontal offset test. Dummy readings indicated good protection of the knees and femurs of both the driver and passenger but structures in the dashboard on the driver's side were thought to present a risk of injury to occupants of different sizes and to those sat in different positions. In the full-width rigid barrier test, head injury values based on decelerations indicated poor protection for this part of the body and all points for the driver dummy were lost. Dummy readings for the head of the rear passenger were good, but it moved too far forward in the test, and protection was rated as marginal. In the side barrier test, the Duster provided good protection to all critical body areas and scored maximum points. Even in the more severe side pole test, protection of the chest was adequate and that of other body areas was good. Tests on the front seats and head restraints demonstrated marginal protection against whiplash injuries in the event of a rear-end collision. A geometric assessment of the rear seats also indicated marginal whiplash protection.

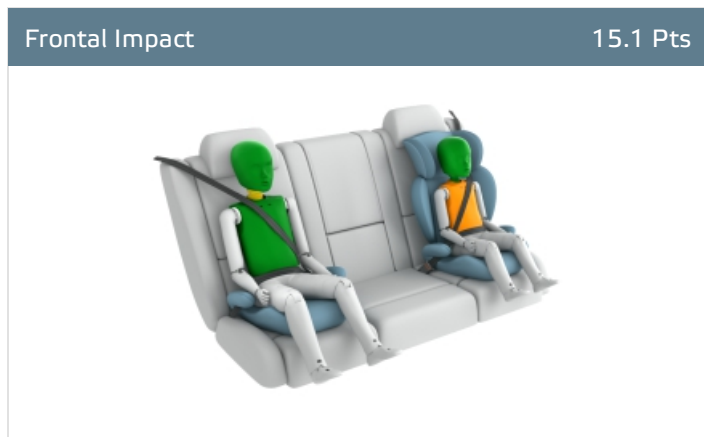
Crash Test Performance based on 6 & 10 year old children

In the frontal offset test, dummy readings in the 6 year dummy indicated marginal chest protection but, otherwise, protection was good or adequate for both dummies. In the side barrier test, protection of all critical parts of the body was good for both child dummies. The front passenger airbag can be disabled to allow a rearward-facing child restraint to be used in that seating position. Clear information is provided to the driver regarding the status of the airbag and the system was rewarded. The marking of ISOFIX/i-Size anchorages in the rear outboard seats did not meet Euro NCAP's requirements so the installation check of all such restraints is indicated as a partial fail, although the restraints could be installed and accommodated in the car. Universal restraints are not allowed in the front passenger seat so the installation checks are deemed to have failed.
